**Docket No. 217 – Development and Management Plan Inspection**

Northeast Utilities Service Company Certificate of Environmental Compatibility and Public Need for the construction of a 345-kV electric transmission line and reconstruction of an existing 115-kV electric transmission line between Connecticut Light and Power Company's Plumtree Substation in Bethel, through the towns of Redding, Weston, and Wilton, and to the Norwalk Substation in Norwalk, Connecticut.

**Date:** September 21, 2005

**Location:** 115 kV Underground Route

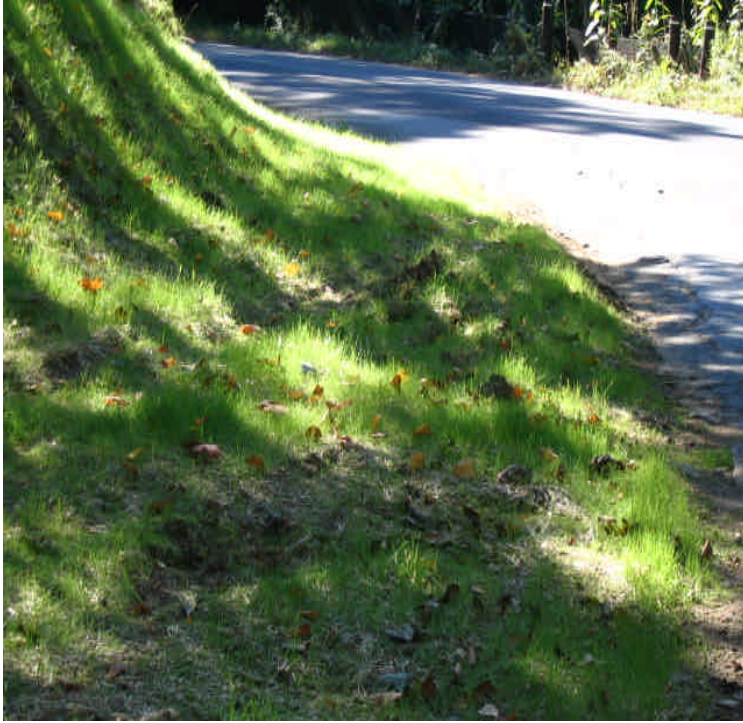
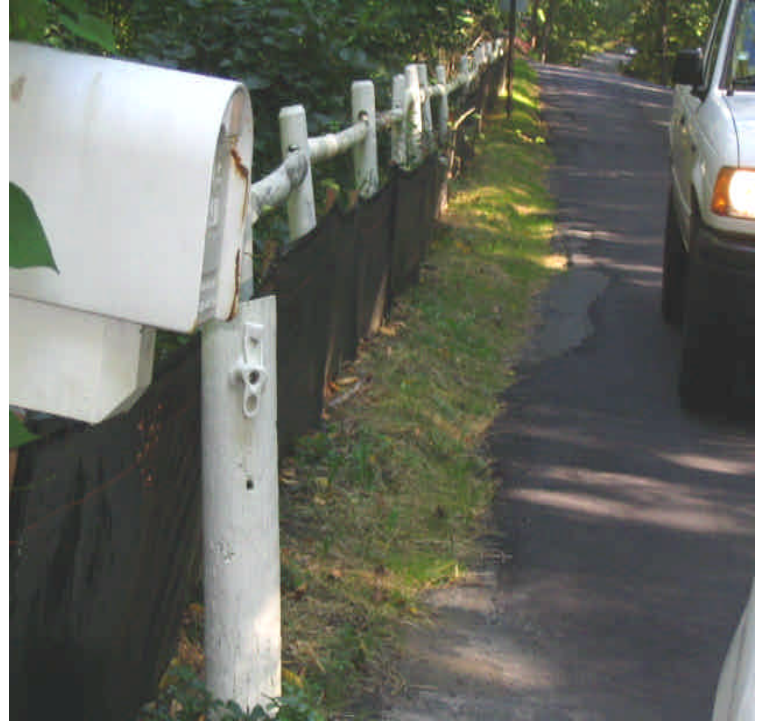
**115kV (Gallows Hill Rd):** The photo on the left shows good regrowth of vegetation near the intersection of the ROW with Gallows Hill. Photo on the right shows an area where silt fence could be removed as the area is stabilized. (9/21/05)

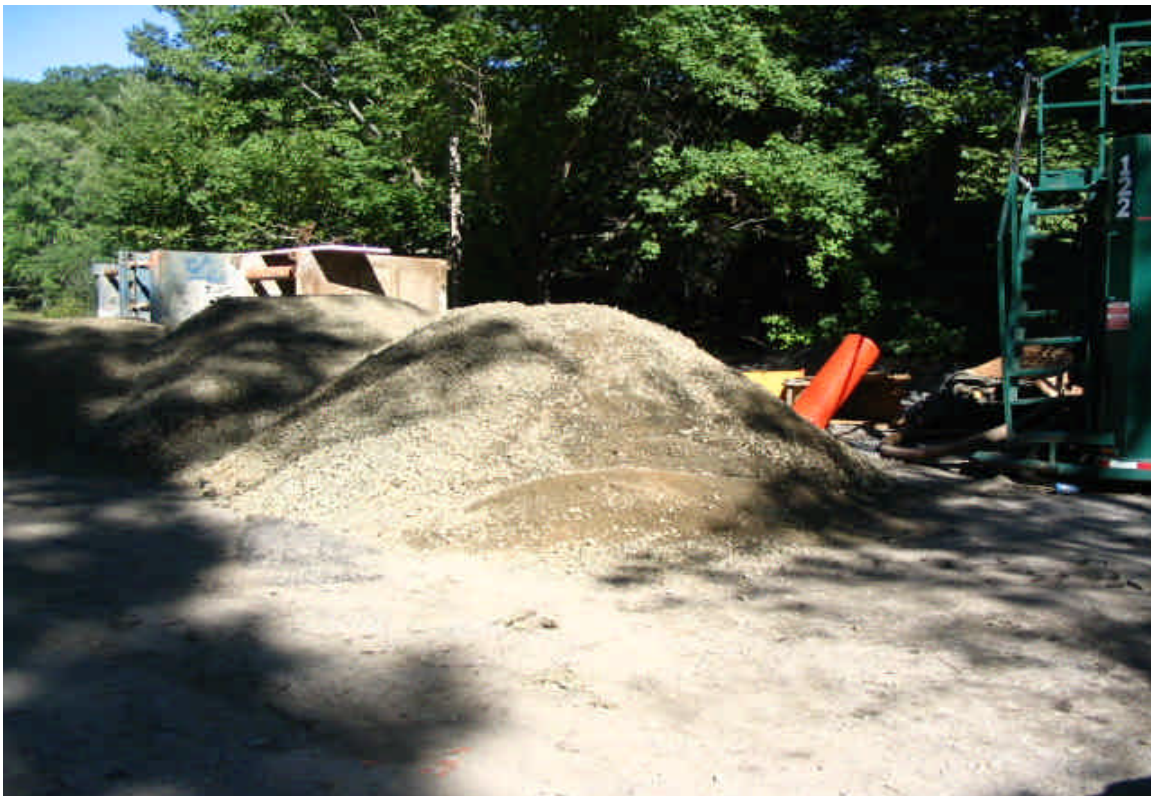
**115kV (Rt. 58)** The storage area near Putnam Park is still well contained in silt fence with new stockpiles of stone. Some cleanup here is still recommended. (9/21/05)

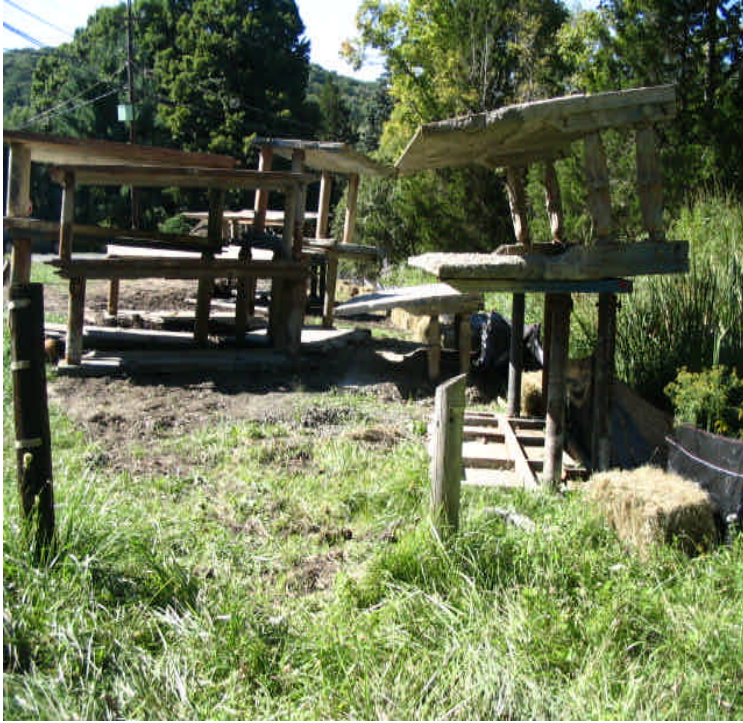
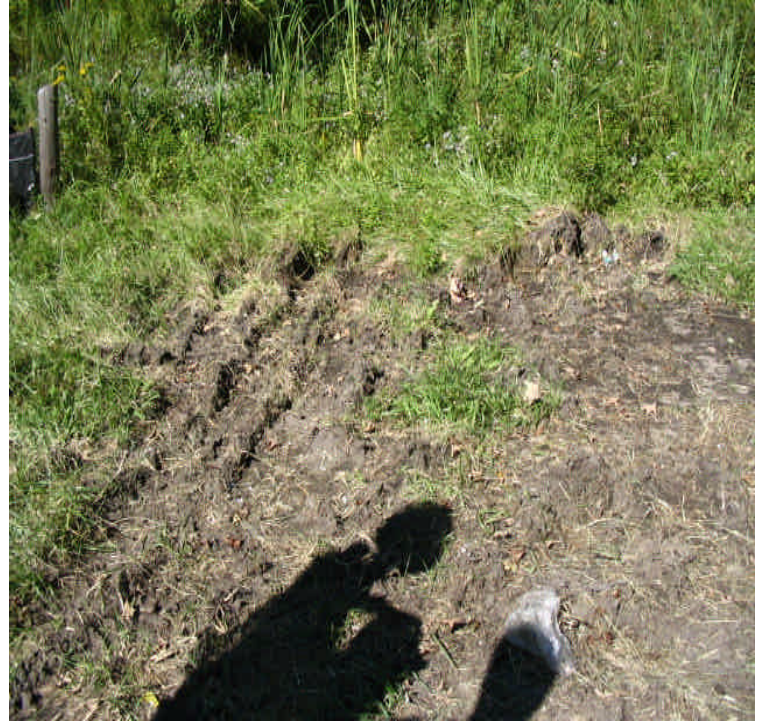
The silt fence at the Sunset Hill Rd. storage area had been repaired and is in good shape. The photo on the right shows an adjacent area where vehicles had caused disturbed soil. This area should be restored or enclosed in the silt fence. (9/21/05)

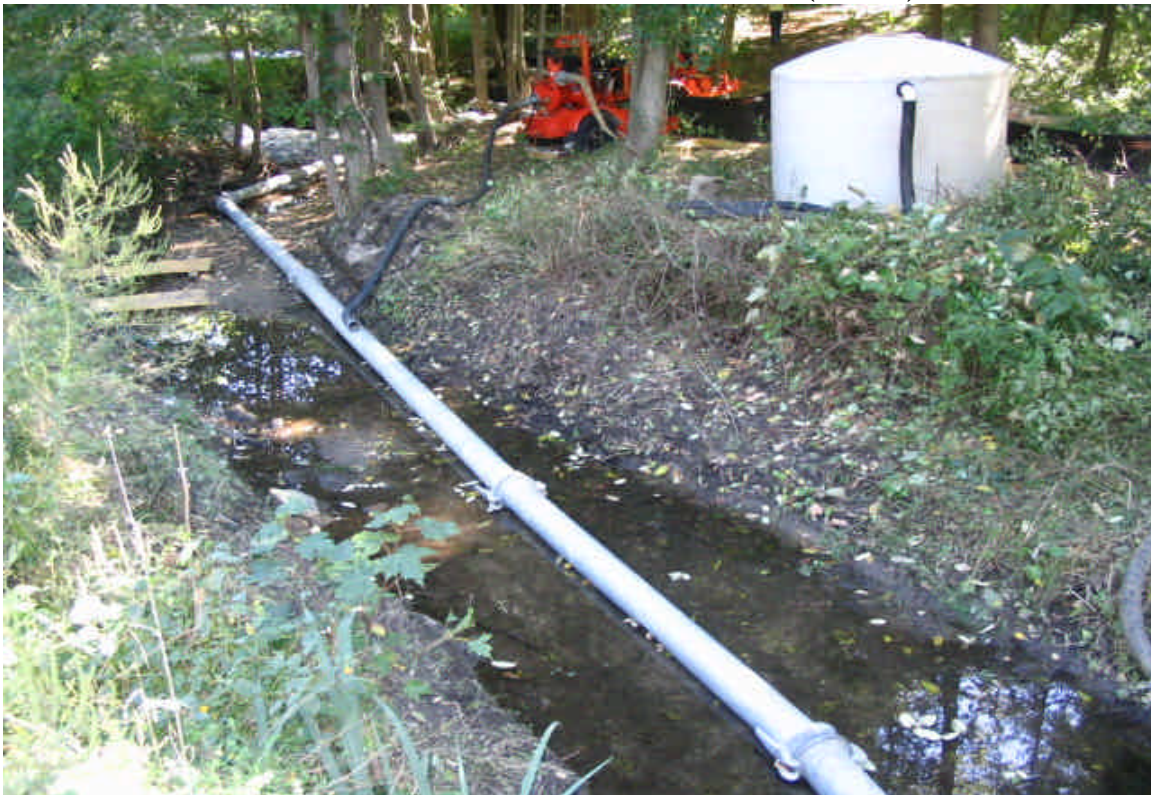
115kV (Rt. 58 Stream cut): View of the preparation for the open cut of the stream near Sara's Way. The section of the stream has been flumed and will be dewatered. (9/21/05)

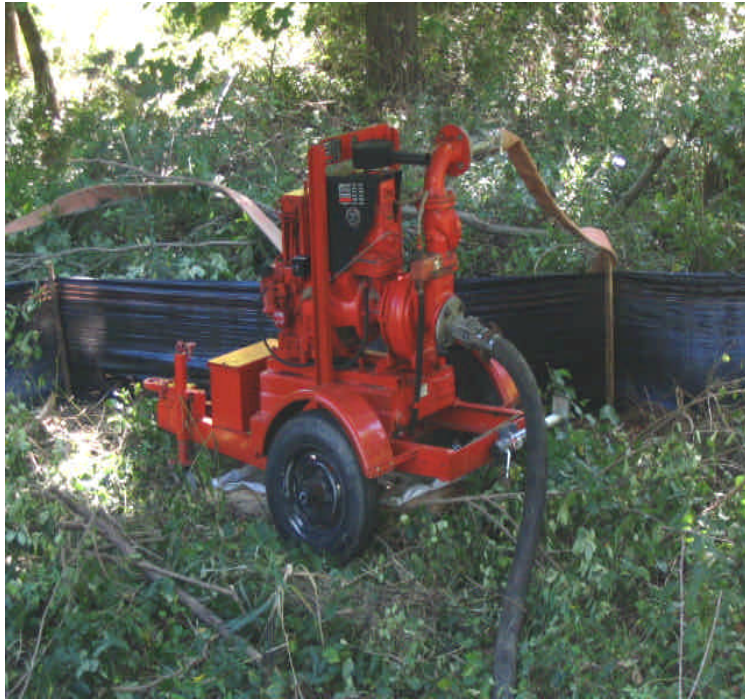
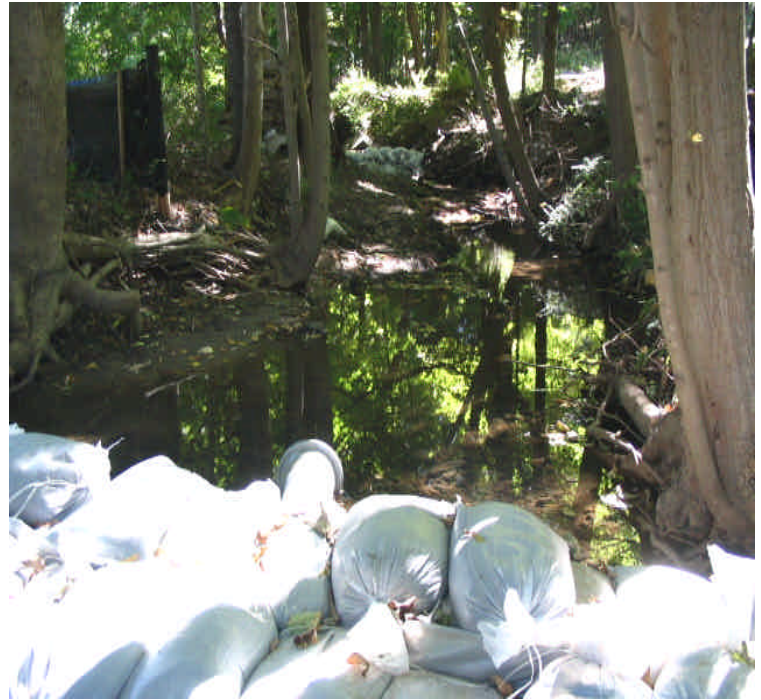
Photo on the left shows good containment of each pump to prevent any fuel leaks. A wooden pan lined with plastic was placed under each. Photo on the right shows the flume entrance and the sandbag dam. (9/21/05)

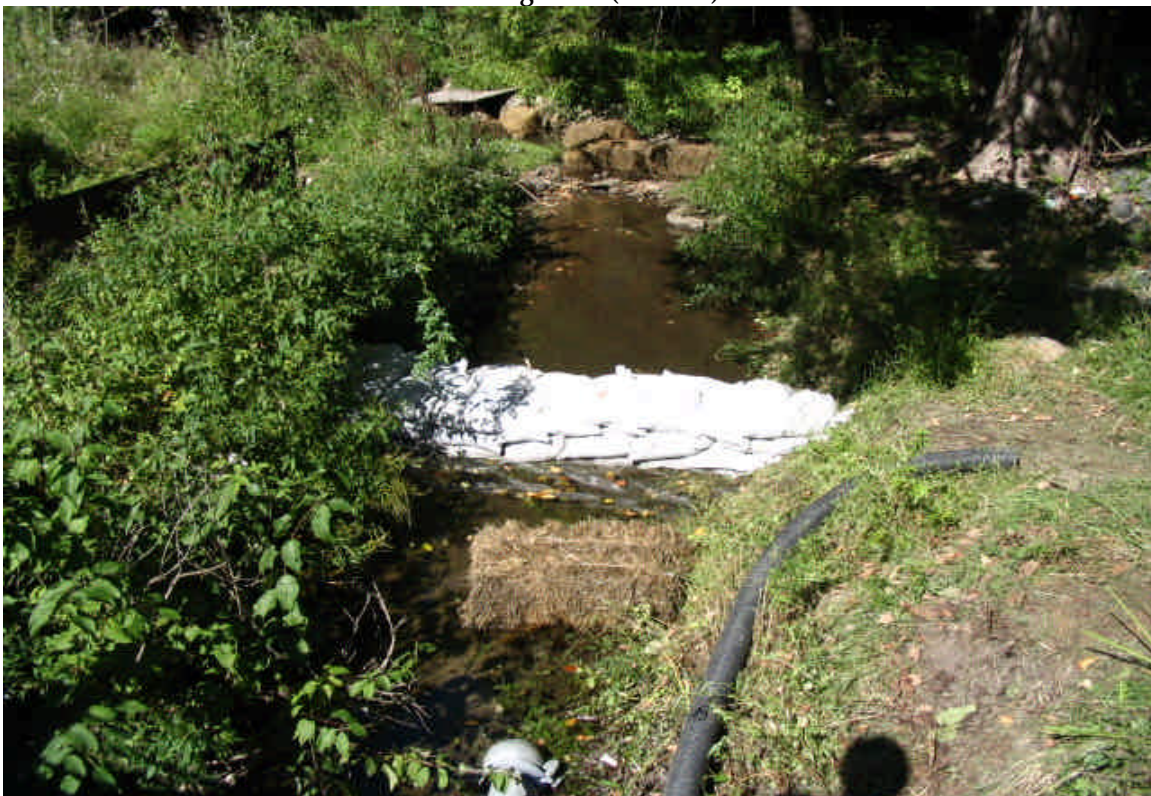
View of the downstream area where the flume outlets. Haybale check dams and sandbags were placed in the stream channel to reduce velocity at the discharge point. The water remained clear at this time. (9/21/05)

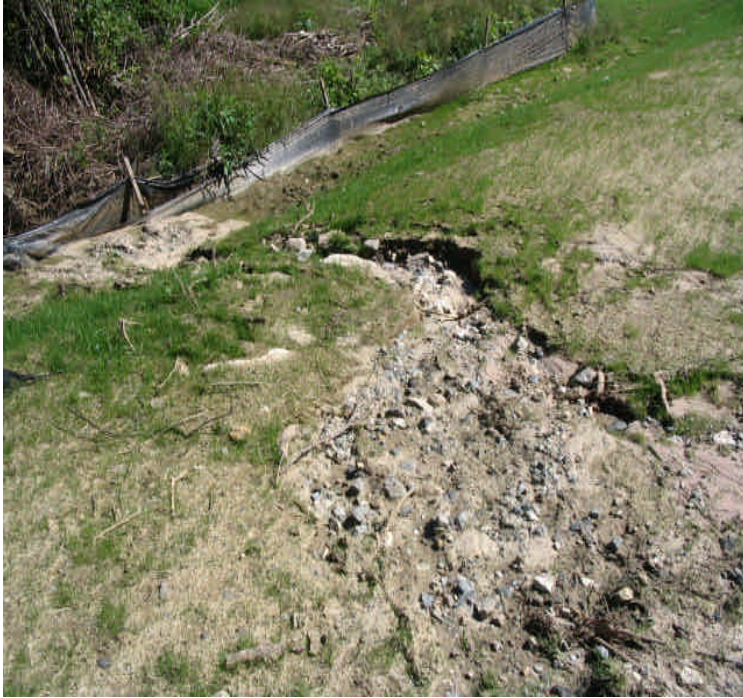
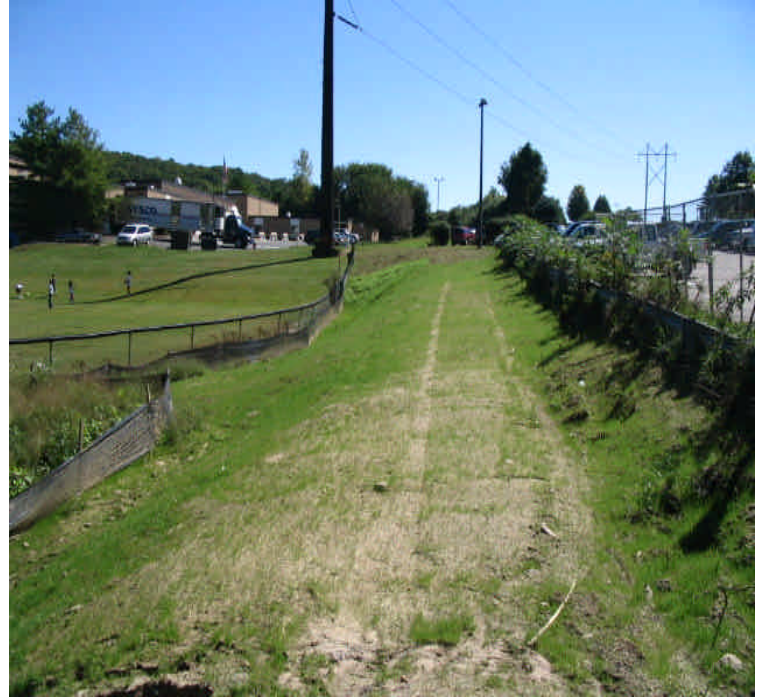
**115kV (Bethel Educational Park):** Photo on the left shows an erosive gully that formed at the northern portion of the ROW. The area should be restored and a check dam installed to prevent further issues. The photo on the right shows good regrowth in the ROW. (9/21/05)

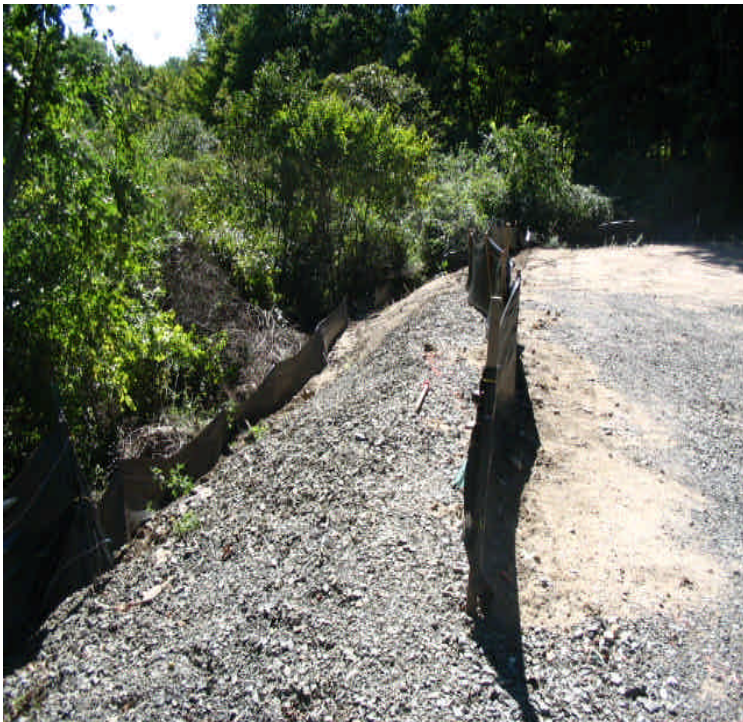
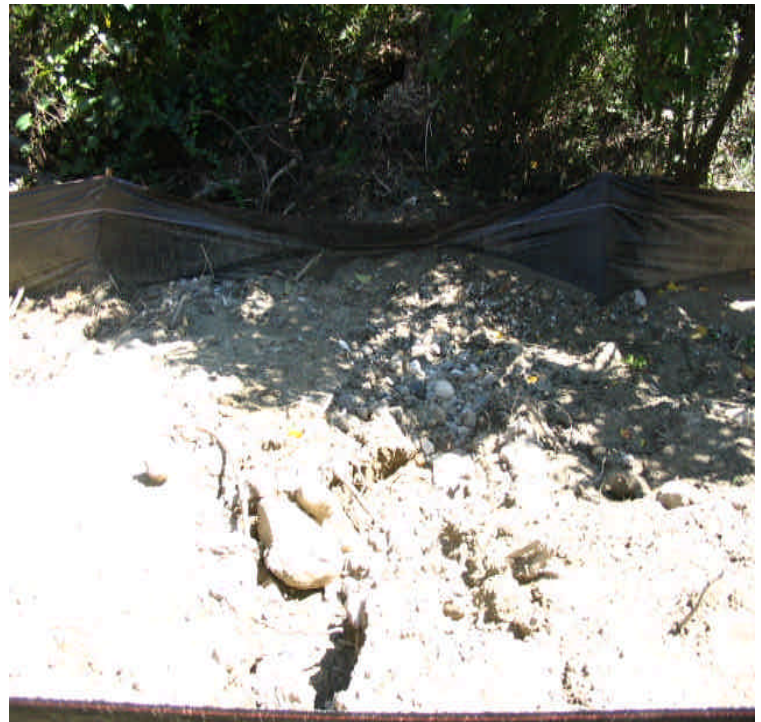
Photo on the left shows the double silt fence well installed at the southern ROW caisson foundation. The photo on the right shows where an erosive gully formed under the first fence and led down to the second. The fence and gully area should be restored. (9/21/05)
